Luxaviation Europe Safety Matters

Welcome to the Luxaviation Group Safety Matters Newsletter

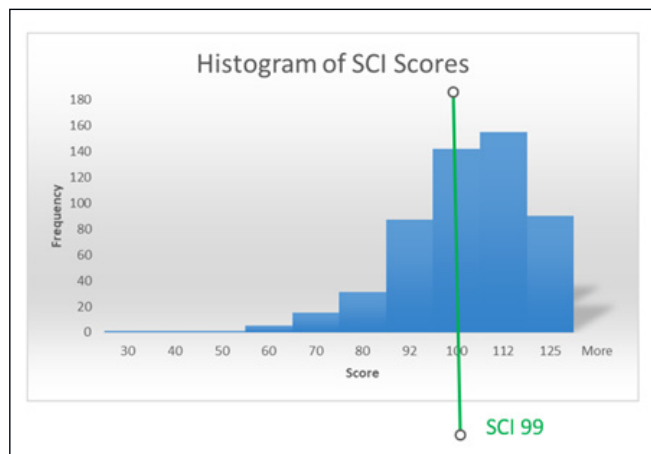
Table 1: Histogram of SCI 2022

528 people completed the survey from across all entities. Overall, the Luxaviation Group SCI was 99. The histogram of scores identified that the range of scores of 27 at the lowest and 125 at the highest, with a skewed distribution towards the higher values, indicating a positive safety culture.

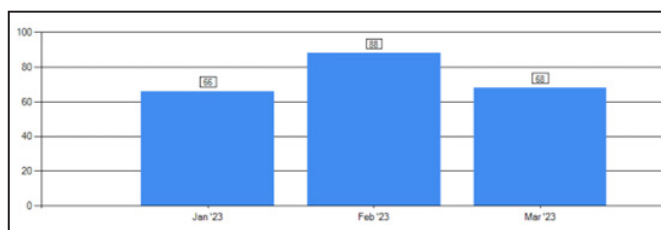
Figure 1: Total number of reports submitted in Centrik in Q1 2023

A positive reporting culture is an important indication of an effective safety culture. Therefore colleagues are encouraged to report hazards pro-actively so that they can be assessed and monitored. There were a total of 222 safety reports submitted in Centrik in Q1.

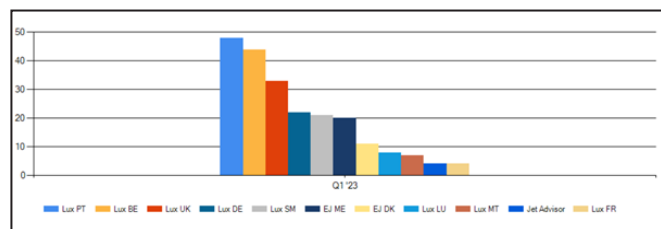
Figure 2: Reports broken down by Entity

There are 11 entities reporting in Centrik and the following shows the breakdown of those reports by entity. The following figure identifies the total number of reports broken down by entity (*excludes ExecuJet Asia Pacific and South Africa.)
